2017 Work News – April, May and June

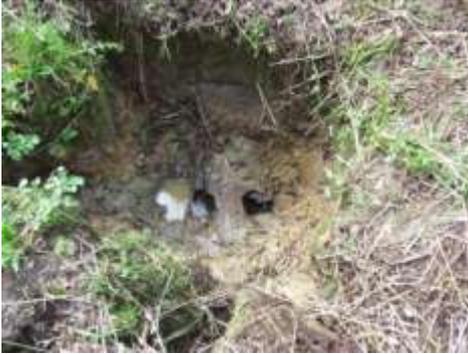
The exposed rotten drainage pipe near the Holsworthy branch had been draining water from the canal for a long period of time, dragging silt into the now cleared ditch which had started to impede the higher field drainage. It was found to be in need of some serious repair work after clearing all the surrounding vegetation and accumulated silt down to the clay bed and materials had to be ordered. (photo 1)

1 exposed rotten wood culvert

A walking survey along part of the Burmsdon section at the beginning of May revealed the beautiful display of Bluebells. (photo 6) which appear here every year. With the purchase of water sealing adhesive, rubber sheeting and the purpose made steel cover the repair of the rotten wooden culvert was finally carried out in the middle of the month. (photos 7 and 8) before refilling the large cavity in the canal bed with clay.

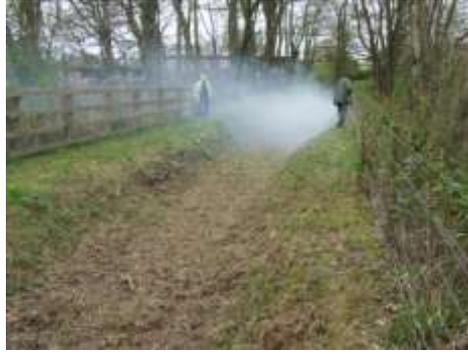
2 cleared back to profile

Still in April, the canal profile in the Aqueduct section over the river Tamar was cleared of all the new vegetation (photo 2) and the large amount of new vegetation was cleared from the turning area at the Holsworthy branch. (photo 3) along with another re-cut of the Filter Bed being carried out with the powered hand mower and strimmers, as the ride-on mower was found not to cope. (Photos 4 & 5)

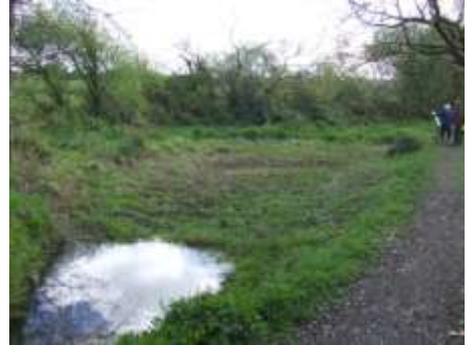
3 view from footpath

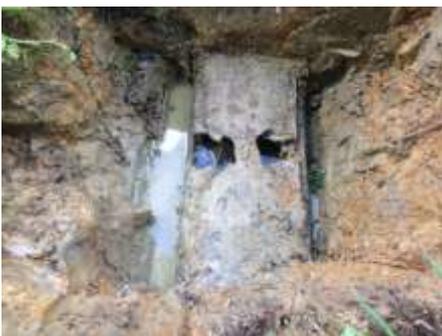
7 slots cut in clay to take support

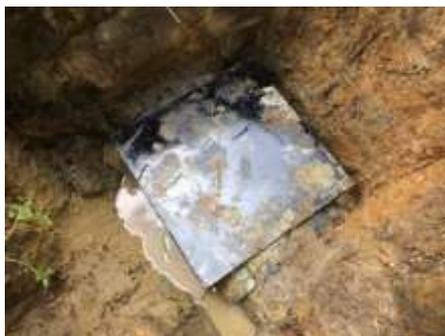
8 ready to overfill with clay

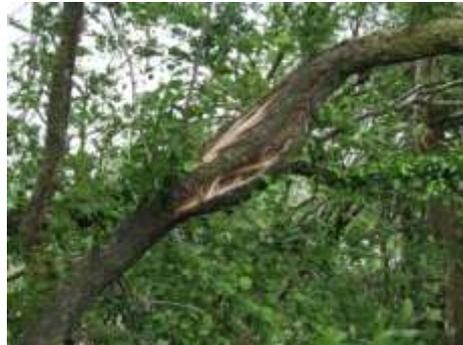
11 tree damage

Moving forward into June with the usual canal maintenance taking priority, the heavy vegetation growth was cut back for two short sections either side of Vealand Bridge (photo 10) tree damage (photo 11) and a new lining pipe was inserted through the repaired wooden culvert to enable a better drainage flow and easier silt removal in the future should it become necessary.(photo 12)

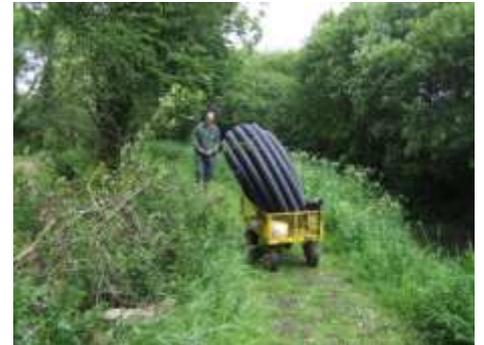
12 culvert liner pipe

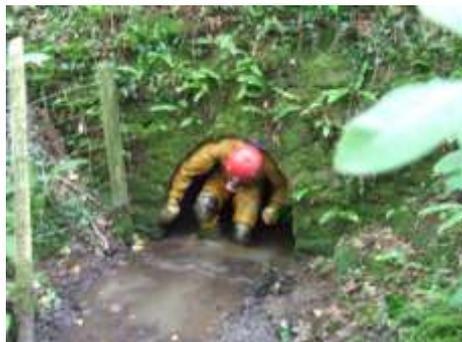
14 exit after first check

The first of several exploratory trips into the Wheel pit drainage culvert proved to be interesting enough to warrant further investigations as part of the autumn program. (photo 14) General maintenance of damaged trees (photo 15) and hedges continued through the month except for during the third week when high temperatures for the country hit the headlines and any prospect of work was called off.

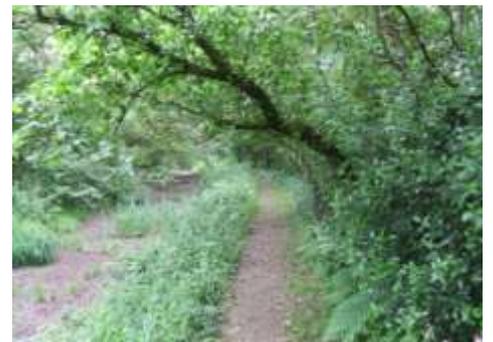
15 third at risk
