2017 Work News.

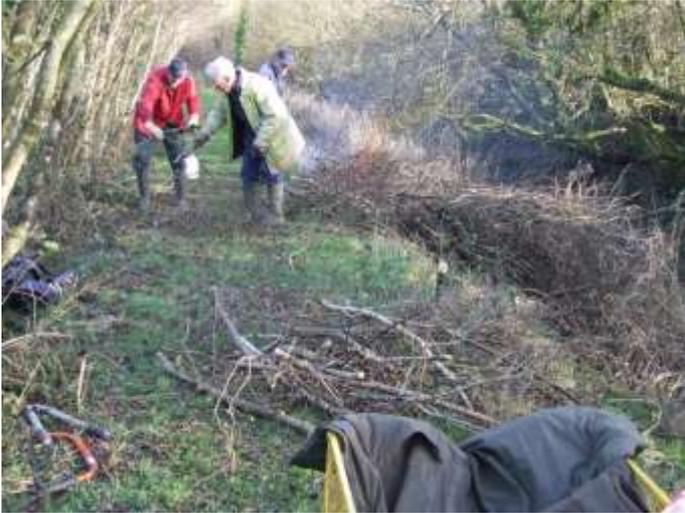
Burning of brash, cut and collected during the autumn of 2016 between Puckland and Dexbeer kept us busy in the first two weeks of **January**. (photo 1.)

1 - Cutting, stacking and burning brash

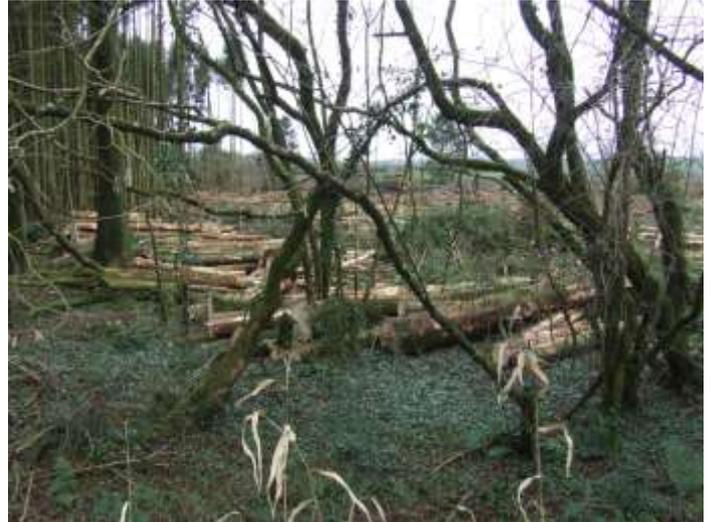
2 - Half gone

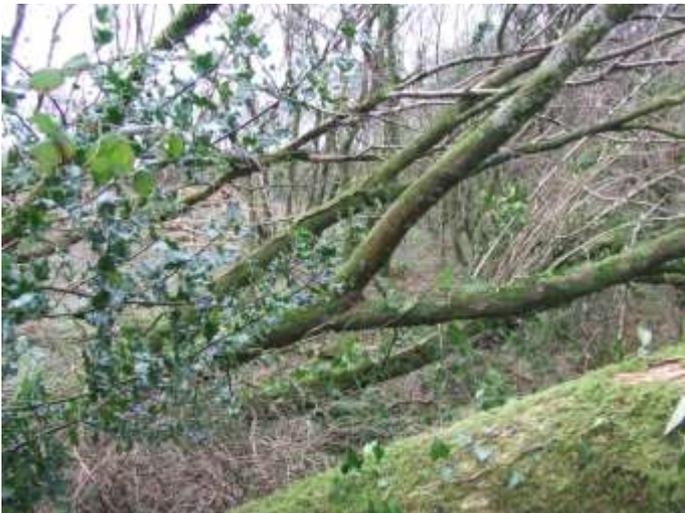
This was followed with a heavy commitment of the work schedule during this and the following two months being concentrated in the area of the Holsworthy branch. Contracted work started right at the beginning of the year to cut down the fir tree plantation known as Brendon Wood on the adjoining land, and by the third week half of the trees had been removed. (Photo 2.) Unfortunately this coincided with a weekend of strong south westerly winds and with much of the protection previously provided by the plantation trees having been removed, it proved too much for many of the remaining trees on both the edge of the plantation and alongside the footpath. (Photo 3 & 4.)

3 - Other small trees

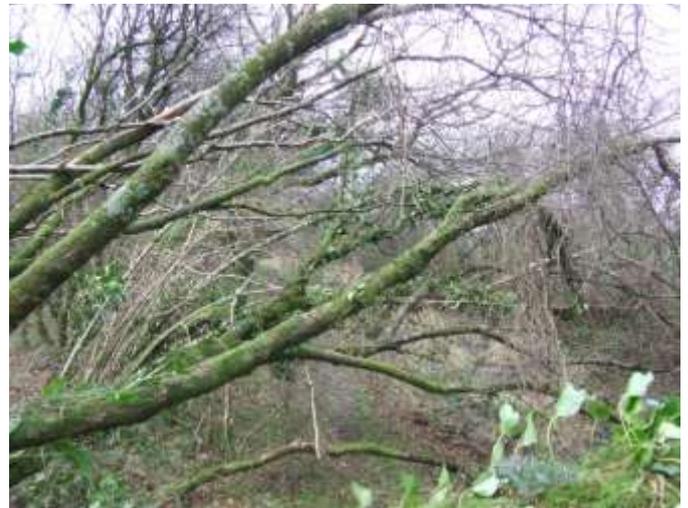
4 – Also across the path and canal

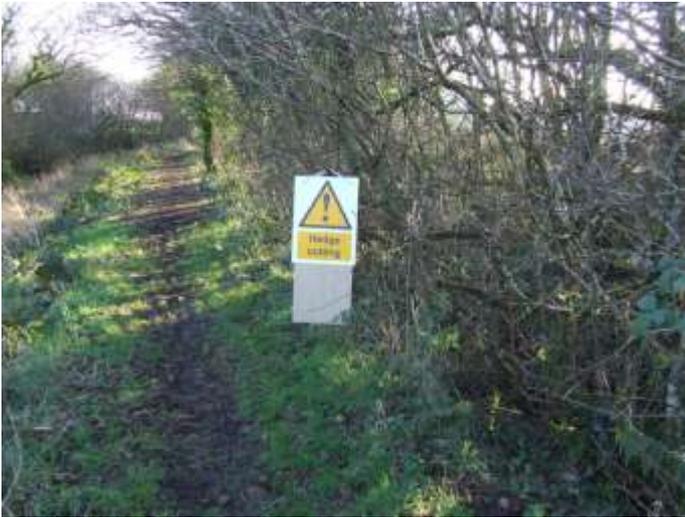
Various trees were identified as being at high risk and following discussions with the contractors and DCC P3 footpath officers, actions were put in place with the contractors and our volunteer hedge layer to resolve the created problems between us whilst enjoying the opened up views.

5 – Warning notices each end

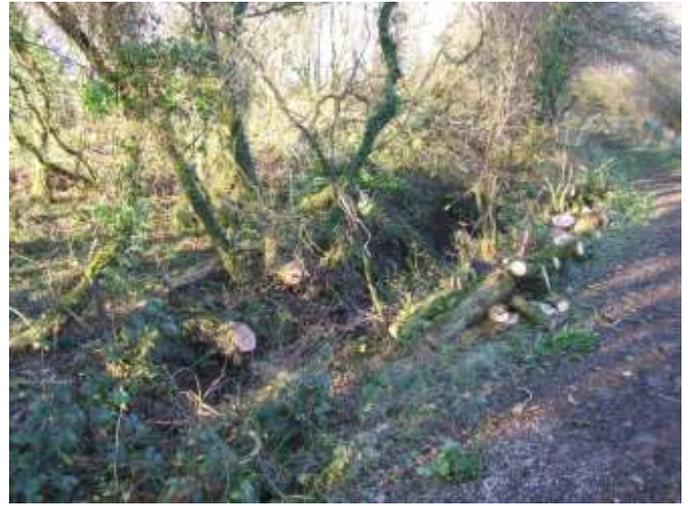
6 – And again, logged up

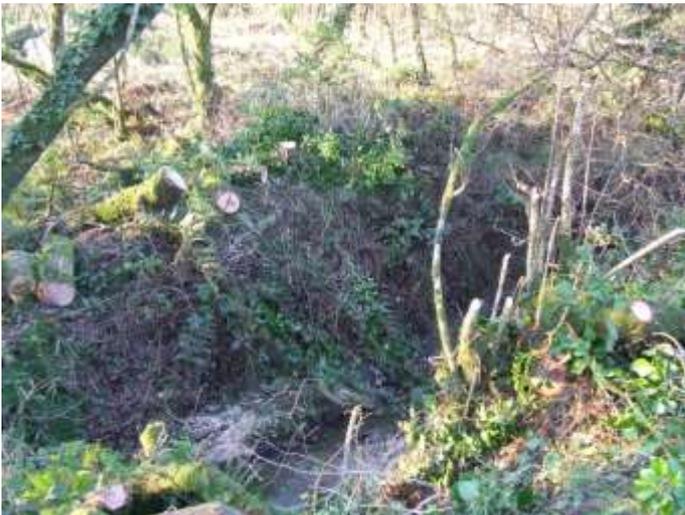
7 – More from marked trees

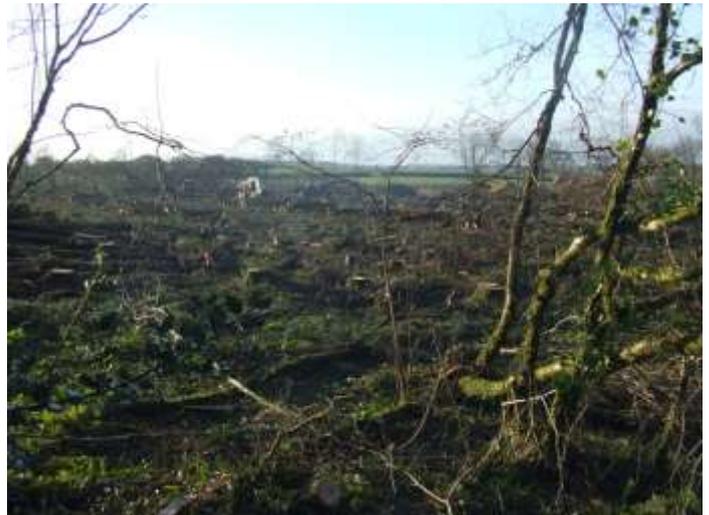
8 – New Countryside view

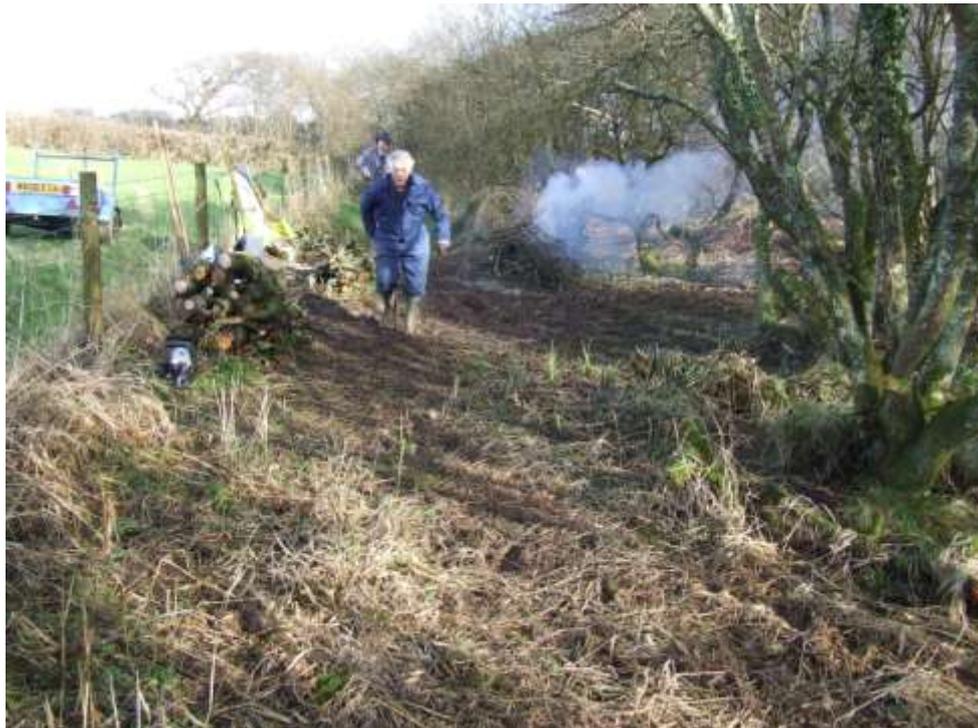
Many years of excess growth, mainly of willow trees were removed to prevent damage to the fence alongside the far end of the Permissive path followed by a burn up. (Photo 9.)

9 – Burmsdon cutting and burning

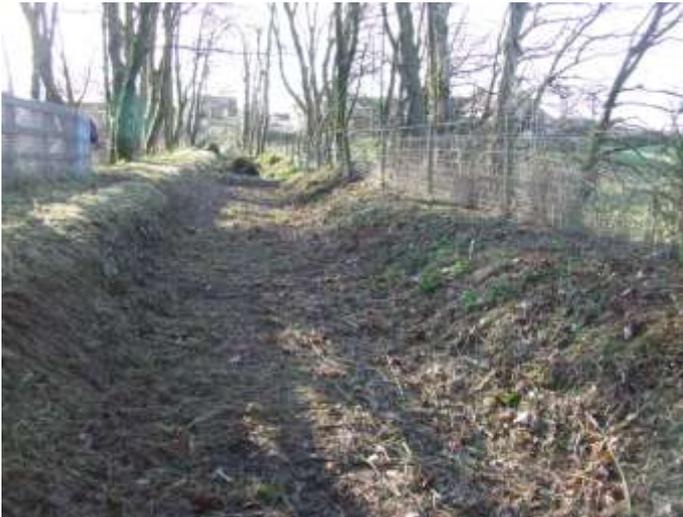
Into **February**, and work continued in the area of the Aqueduct Bridge, clearing vegetation through and beyond Burmsdon Bridge although a mower cut is required as soon as the weather permits. (Photos 10 & 11)

10 – Aqueduct bridge cleared of vegetation

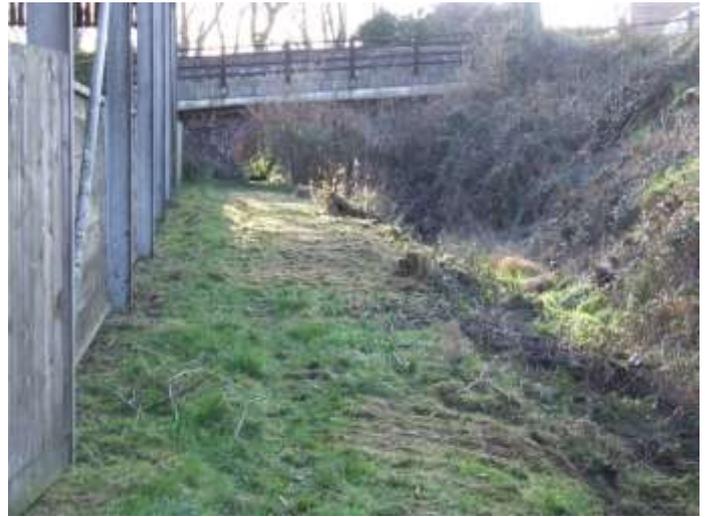
11 – Waiting mower cut

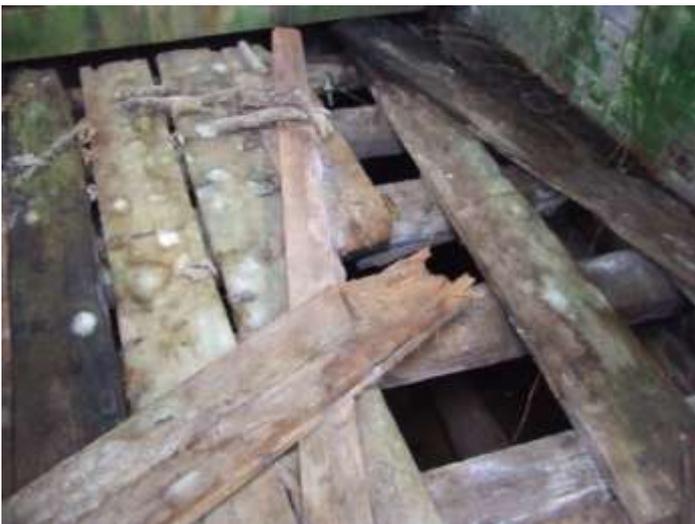
The old South West Water pump building was found to have been damaged, creating access into the building which had a fragile floor over old pipes and several feet of water. Steps were taken to re-secure the building (Photos 12 & 13.)

12 – View inside door

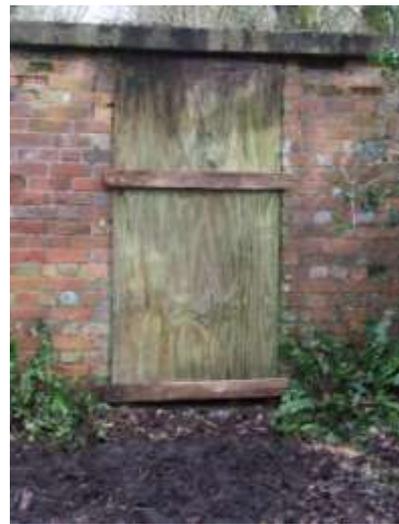
13 – Resealed door

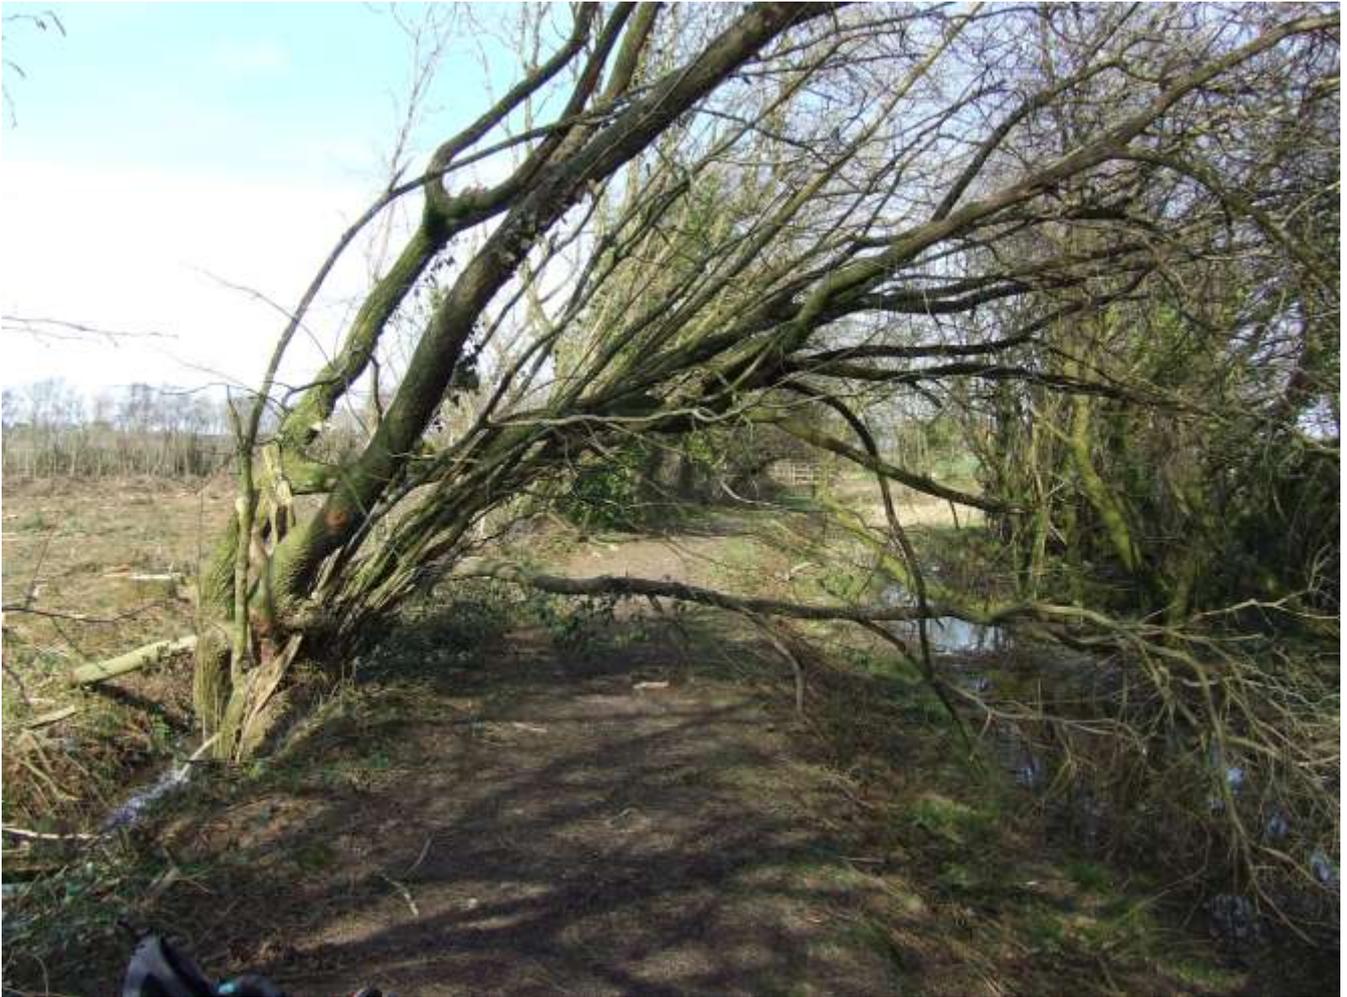
March came in like a lion and more tree damage at Brendon wood had to take priority (Photo 14)

14 – More trees cross footpath

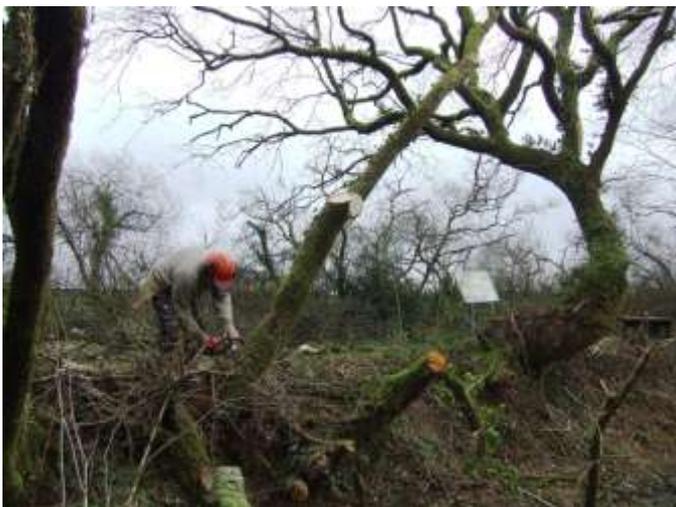
15 – Laying main stem

The decision was made to lay as much of the whole length of threatened trees and saplings whilst leaving as many individual larger ones as possible after reducing the number of branches on the footpath side of their main trunks. (Photos 15, 16 & 17)

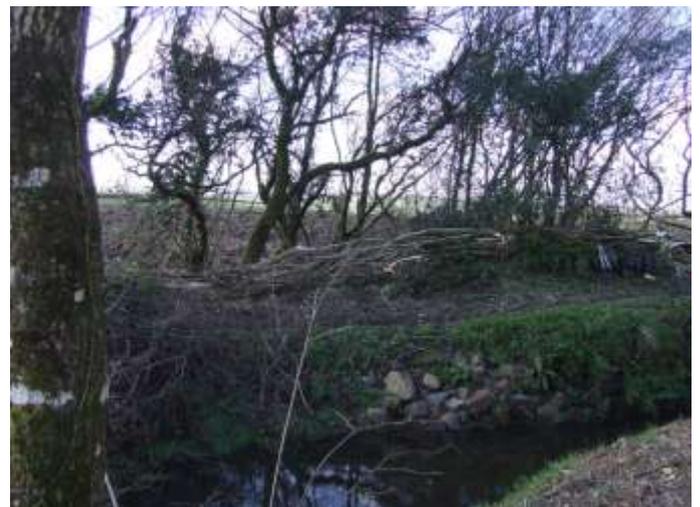
16 – End of season hedge laying

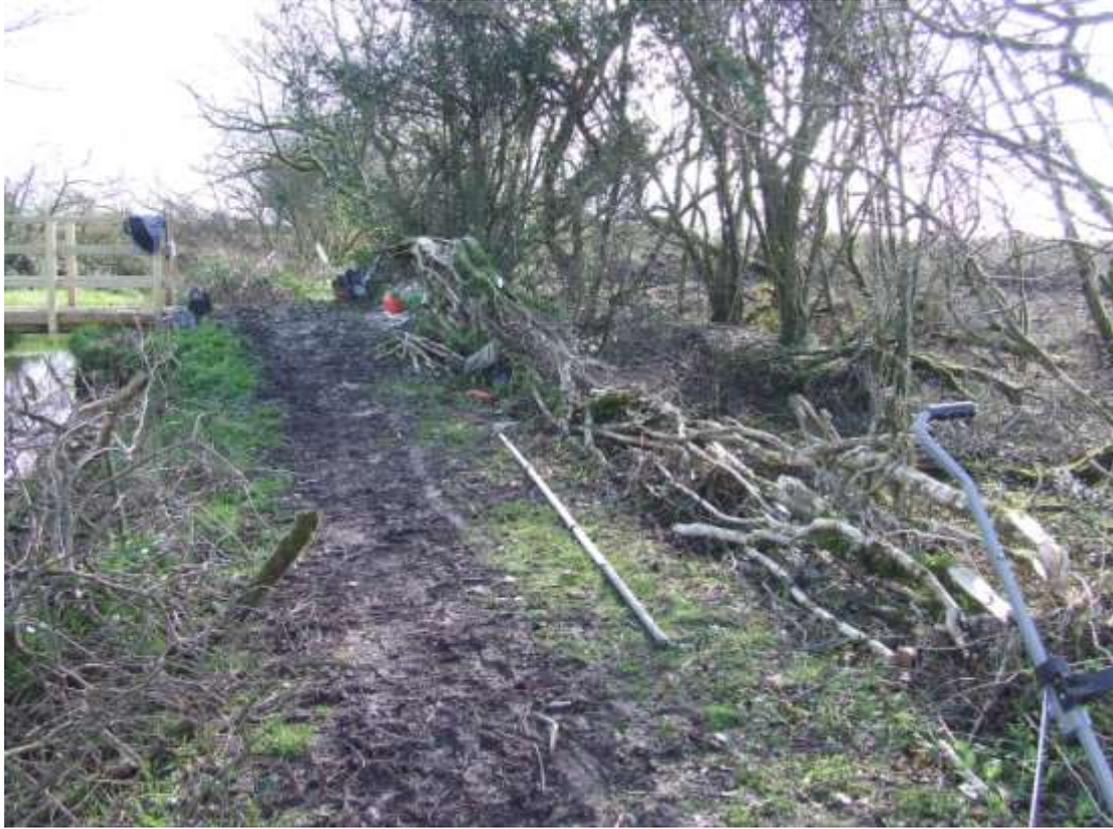
17 – View looking south

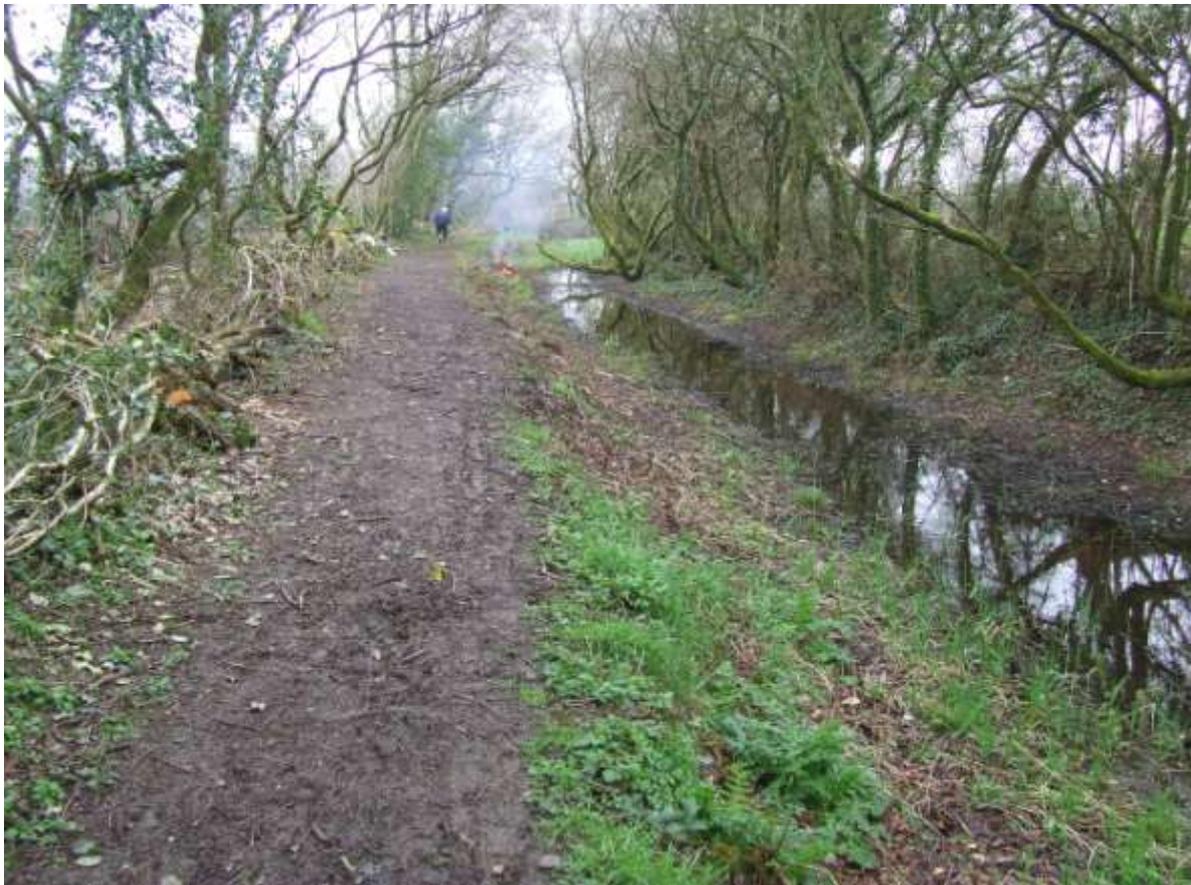
A burn up of the majority of brash was completed on the last week and although the hedge is looking sparse at the moment new leaves are all ready starting to show. (Photo 8.)

18 – Clearing the brash
