# 2017 Work Archive

## January, February and March

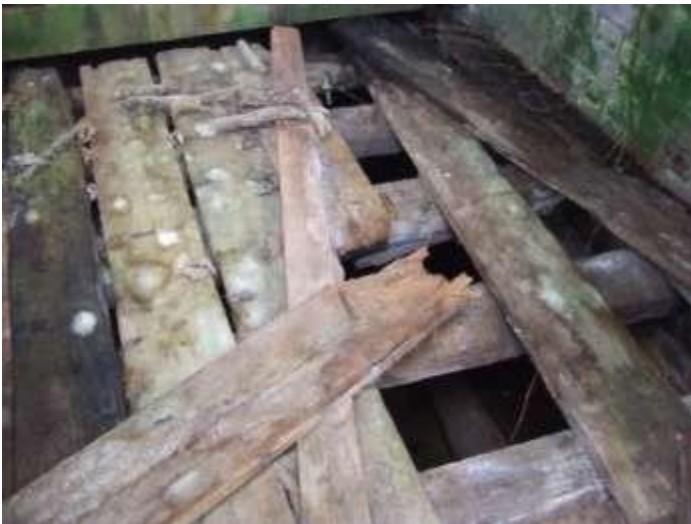
The old South West Water pump building was found to have been damaged, creating access into the building which had a fragile floor over old pipes and several feet of water. Steps were taken to re-secure the building

*12 – View inside door*

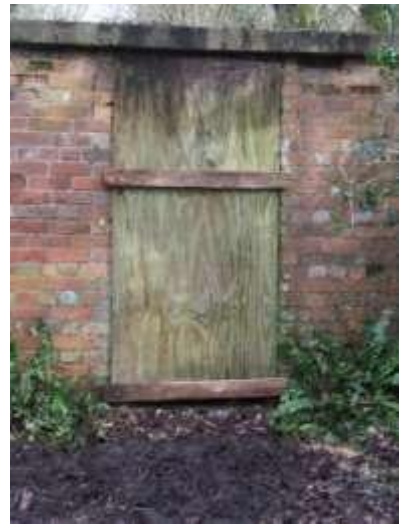
*13 – Resealed door*

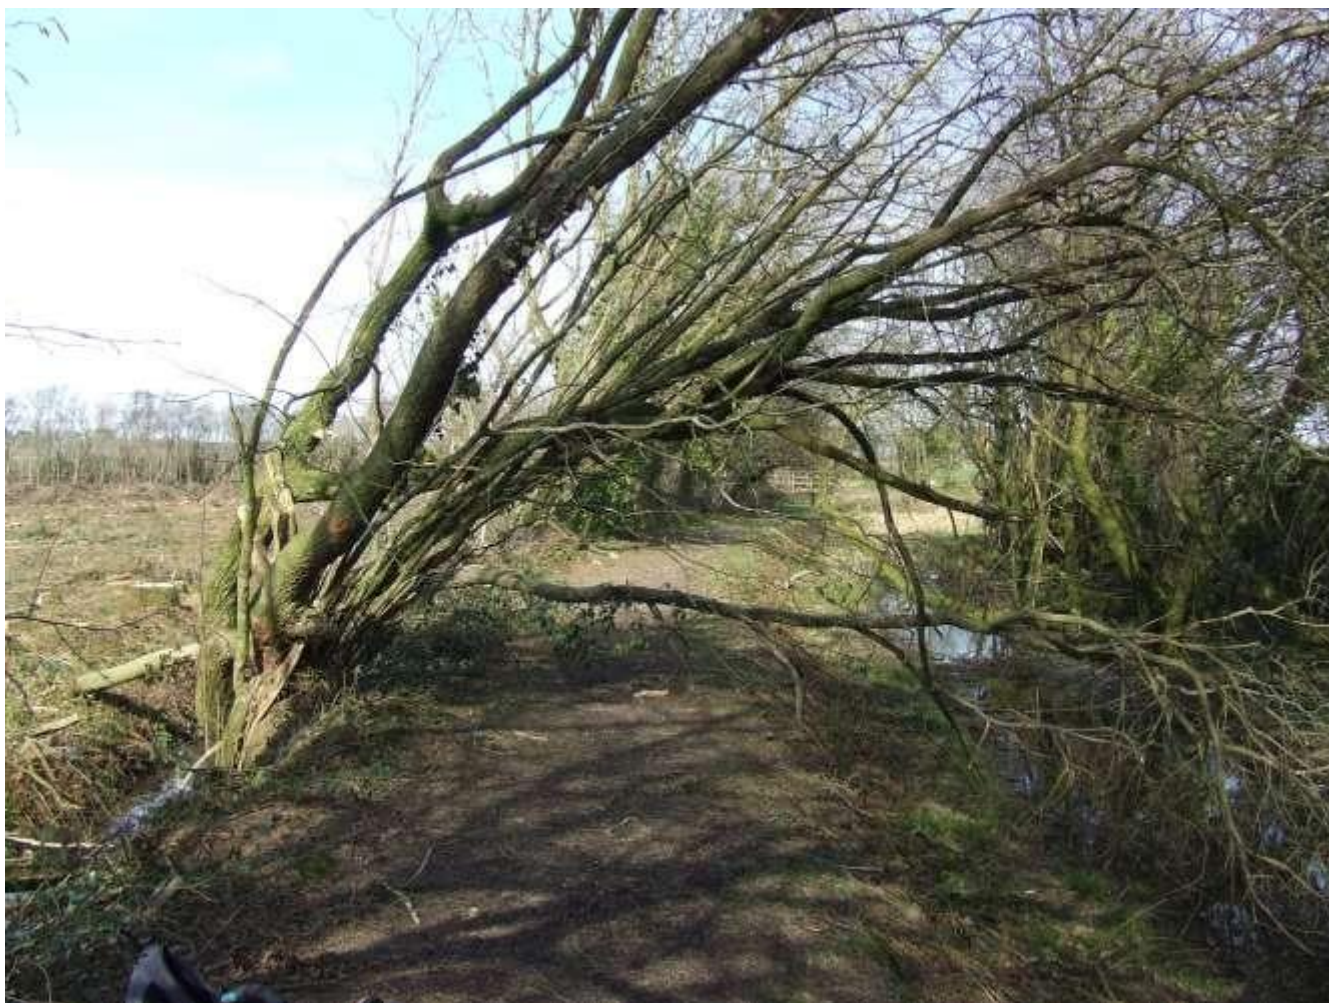
*14 – More trees cross footpath*

The decision was made to lay as much of the whole length of threatened trees and saplings whilst leaving as many individual larger ones as possible after reducing the number of branches on the footpath side of their main trunks.

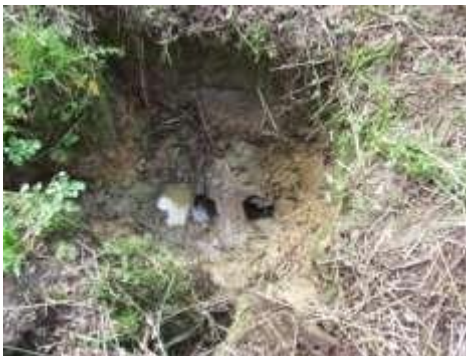
The exposed rotten drainage pipe near the Holsworthy branch had been draining water from the canal for a long period of time, dragging silt into the now cleared ditch which had started to impede the higher field drainage. It was found to be in need of some serious repair work after clearing all the surrounding vegetation and accumulated silt down to the clay bed and materials had to be ordered.

1 exposed rotten wood culvert

A walking survey along part of the Burmson section at the beginning of May revealed the beautiful display of Bluebell which appear here every year. With the purchase of water sealing adhesive, rubber sheeting and the purpose made steel cover the repair of the rotten wooden culvert was finally carried out in the middle of the month. before refilling the large cavity in the canal bed with clay.

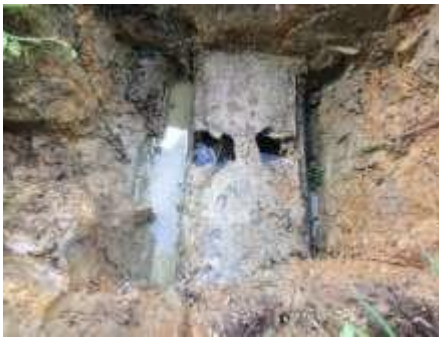
7 slots cut in clay to take support

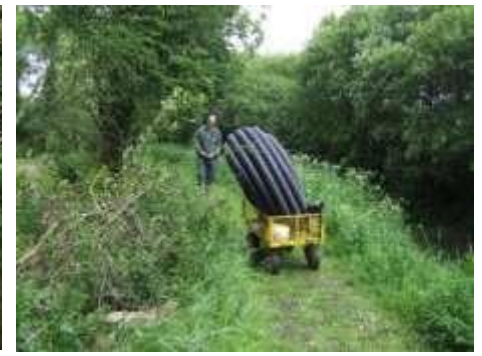
12 culvert liner pipe

Moving forward into June with the usual canal maintenance taking priority, the heavy vegetation growth was cut back for two short sections either side of Vealand Bridge tree damage and a new lining pipe was inserted through the repaired wooden culvert to enable a better drainage flow and easier silt removal in the future should it become necessary

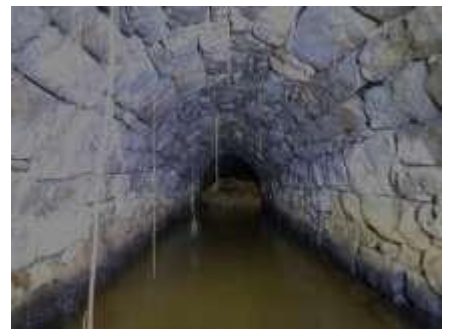
12 entrance lined tunnel looking into fallen soft ceiling

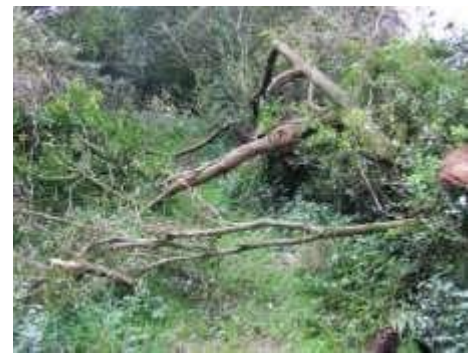
21 some of the reported trees down

September, and the last of the hand dredging and weed pulling north of Virworthy Bridge was surveyed by the team at the end of the day. The planned Permissive Path mowing and general vegetation clearance had to be postponed after receiving a report from a walker that several small trees had been blown across the footpath which were cleared.

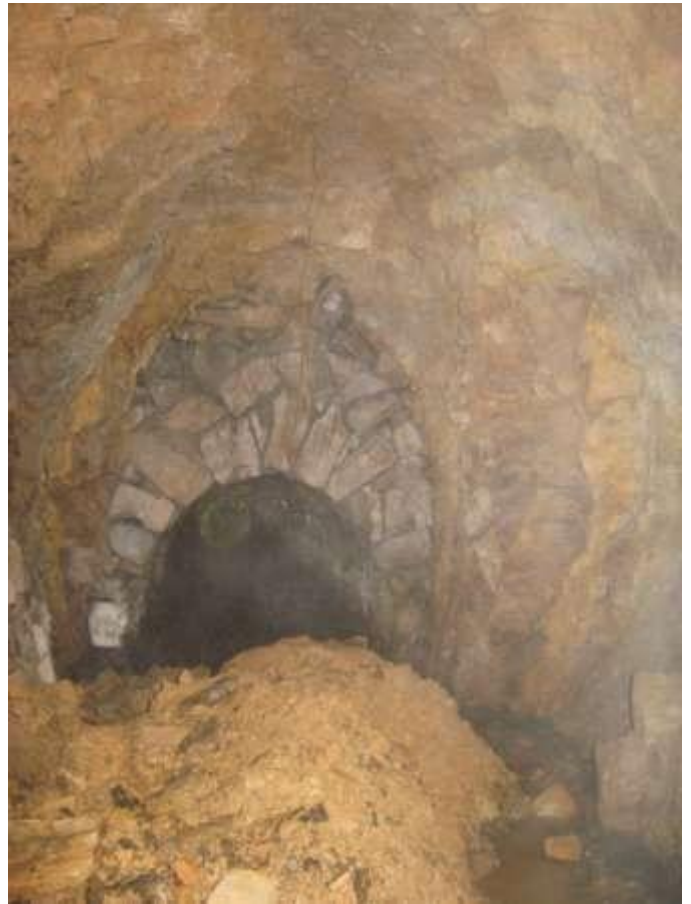
Photographs provided by the cavers and accompanying archaeologist indicated that in two areas where the culvert was tunnelled through a mixture of shale and clay there had been partial roof falls creating a potential hazardous situation for inquisitive inexperienced individuals.

10 Roof fall material

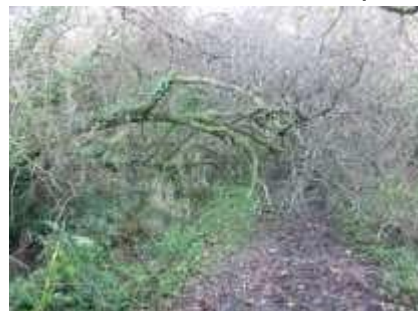
17 blocking footpath

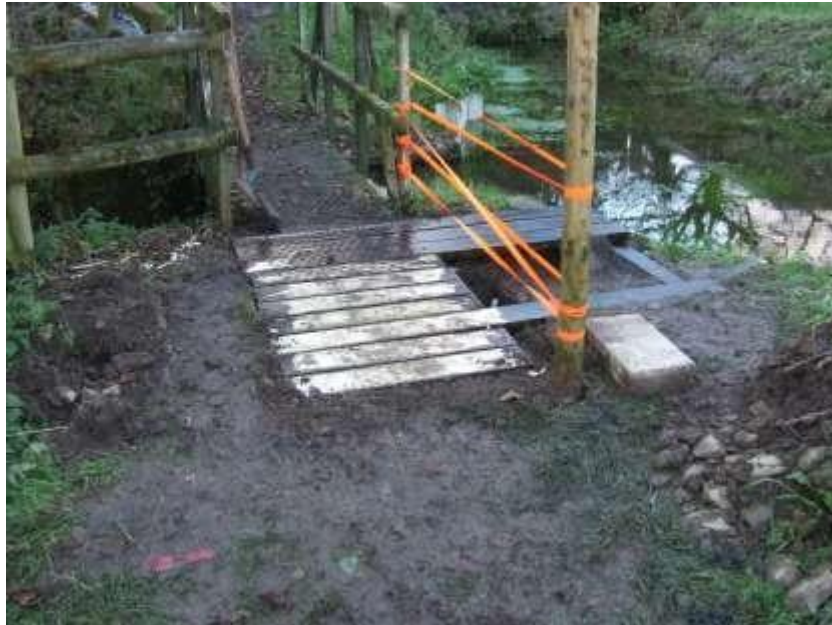
and also commencing work to improving the situation of a potential footpath collapse over the washed out cavity by the long term leak at Virworthy.

19 Footpath boarded over

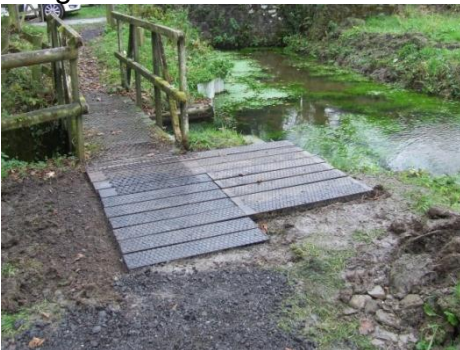
20 Completed boarding

As the repaired leak by the overspill at Virworthy Wharf has been retaining the high water level from the continuous recent rainfall for several weeks, work to finish the construction of bridging over the undermined footpath was completed.
