2017 Work News – April, May and June

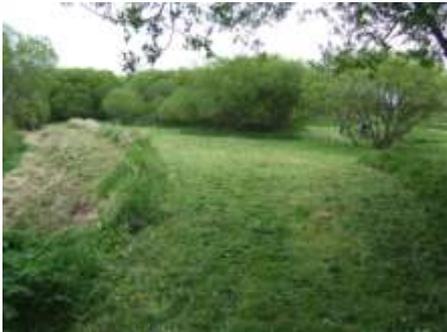
4 well on

Still in April, the canal profile in the Aqueduct section over the river Tamar was cleared of all the new vegetation (photo 2) and the large amount of new vegetation was cleared from the turning area at the Holsworthy branch. (photo 3) along with another re-cut of the Filter Bed being carried out with the powered hand mower and strimmers, as the ride-on mower was found not to cope. (Photos 4 & 5)

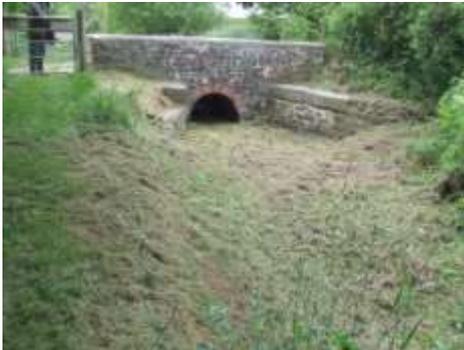
10 after cut back

Moving forward into June with the usual canal maintenance taking priority, the heavy vegetation growth was cut back for two short sections either side of Vealand Bridge (photo 10) tree damage (photo 11) and a new lining pipe was inserted through the repaired wooden culvert to enable a better drainage flow and easier silt removal in the future should it become necessary.(photo 12)
