# 2017 Work Archive

## January, February and March

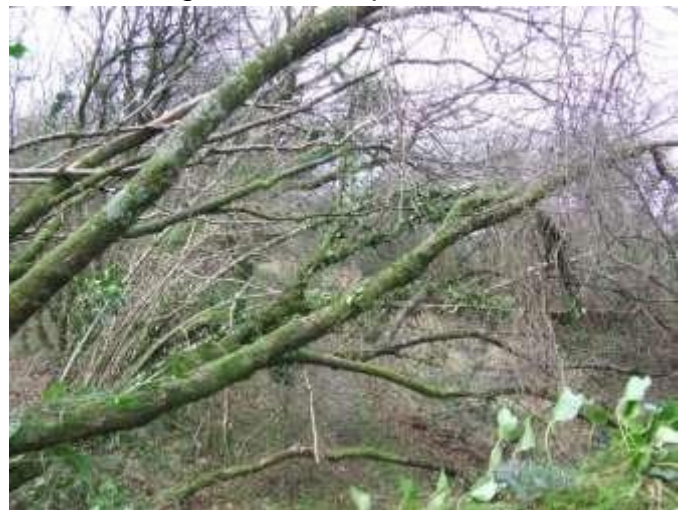
*4 – Also across the path and canal*

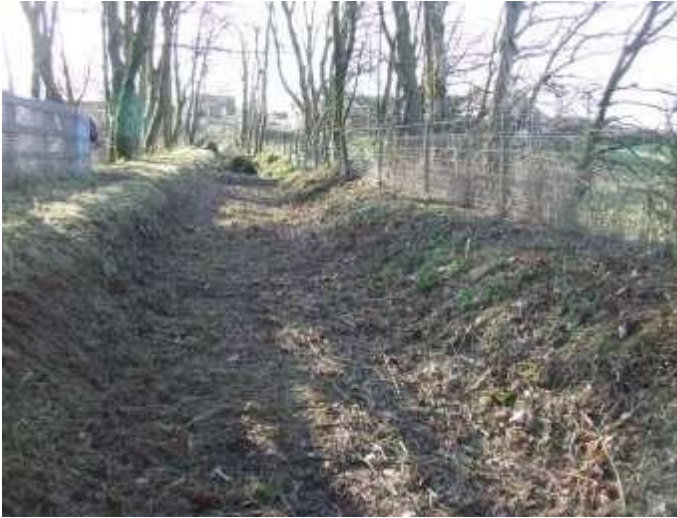
*10 – Aqueduct bridge cleared of vegetation*

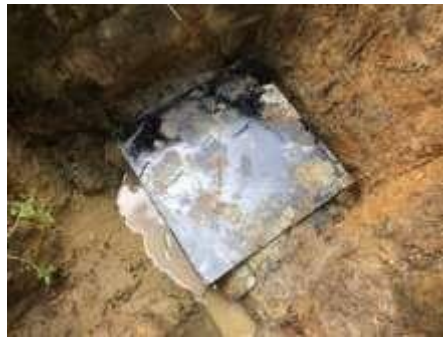
8 ready to overfill with clay

A walking survey along part of the Burmson section at the beginning of May revealed the beautiful display of Bluebell which appear here every year. With the purchase of water sealing adhesive, rubber sheeting and the purpose made steel cover the repair of the rotten wooden culvert was finally carried out in the middle of the month. before refilling the large cavity in the canal bed with clay.

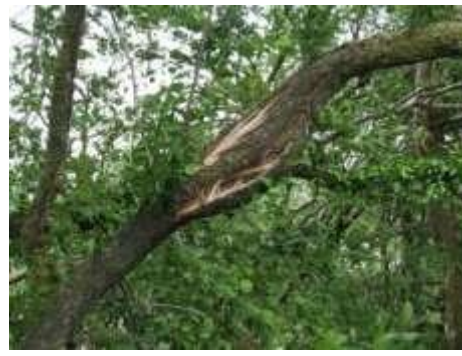
11 tree damage

Moving forward into June with the usual canal maintenance taking priority, the heavy vegetation growth was cut back for two short sections either side of Vealand Bridge tree damage and a new lining pipe was inserted through the repaired wooden culvert to enable a better drainage flow and easier silt removal in the future should it become necessary

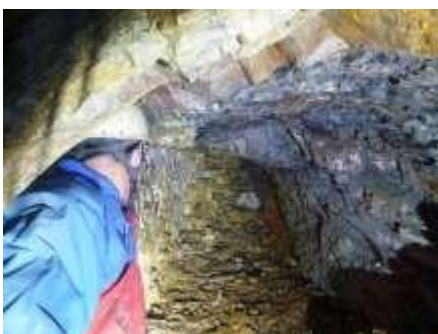
13 loose stones and solid wall

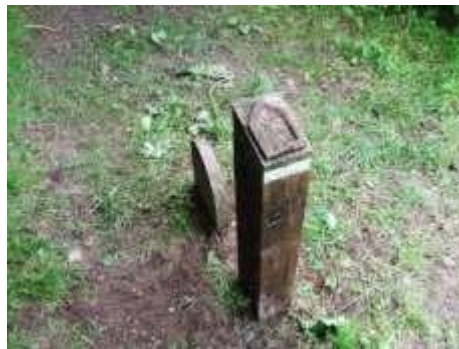
17 post to reduce trip hazard

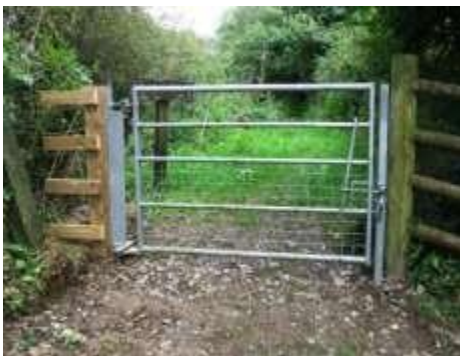
The existing storage shed was moved to make room for a new, more secure store for the work boat and tools. A new gate has been installed at Virworthy Mill to replace the broken one.

19 new gate at Virworthy Mill

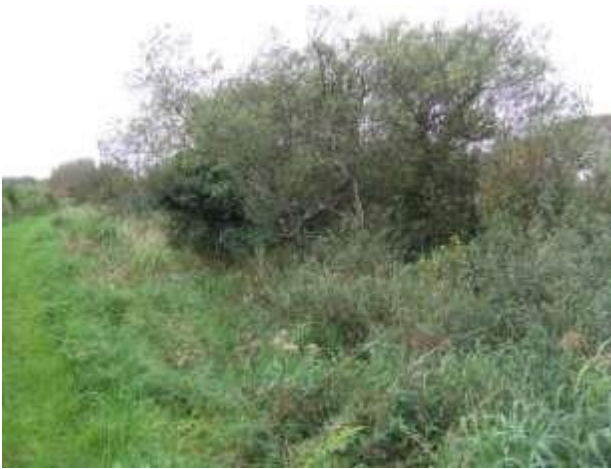
Overhanging trees/branches from the far bank between the Holsworthy Branch and Brendon Bridge were removed during the remainder of the month.

6 General cutback required

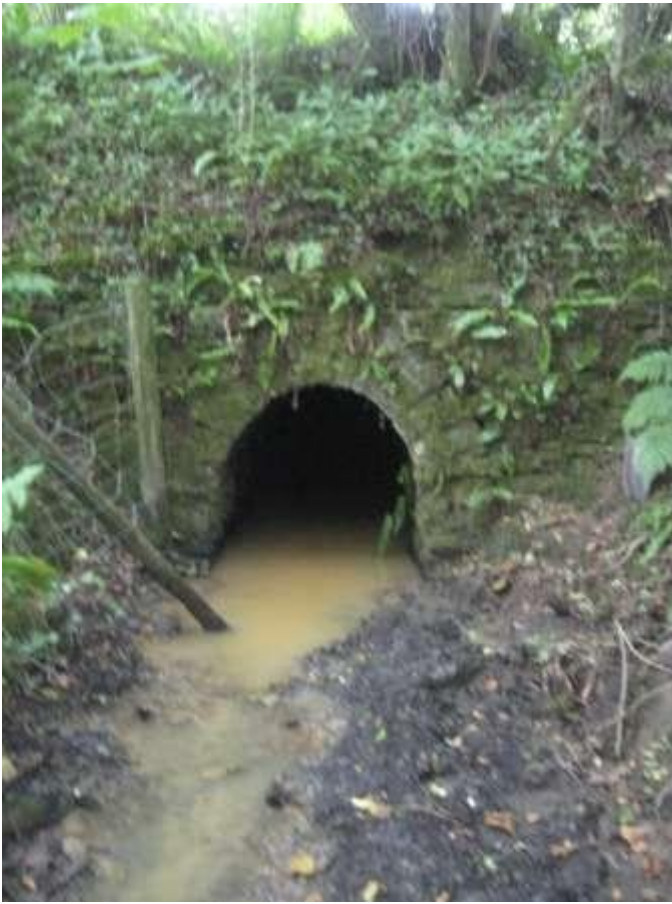
9 Entrance

Photographs provided by the cavers and accompanying archaeologist indicated that in two areas where the culvert was tunnelled through a mixture of shale and clay there had been partial roof falls creating a potential hazardous situation for inquisitive inexperienced individuals.

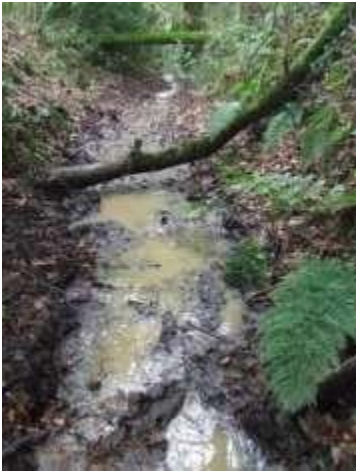
The small amount of water still flowing out of the stoned exit of the adit is presumably seepage of surface water but this has gradually almost silted up the channel to the point that it has at sometime, changed its course away from its purpose of providing a water supply to the next section at base of the Inclined Plane. However, the course of the original channel remains although surprisingly, seems to have just been cut through the surface clay and not been stone lined. Despite being silted up, surface drainage water is still finding its way down and some clearance work of undergrowth and silt removal has begun to open it up again.

13 First section away from adit entrance
